Fort Leavenworth,  
Building # 16  
24 Sumner Place  
Leavenworth  
Leavenworth County  
Kansas

HABS No. KS-53-E

HISTORIC AMERICAN BUILDINGS SURVEY

FORT LEAVENWORTH, BUILDING # 16 HABS No.: KS-53-E

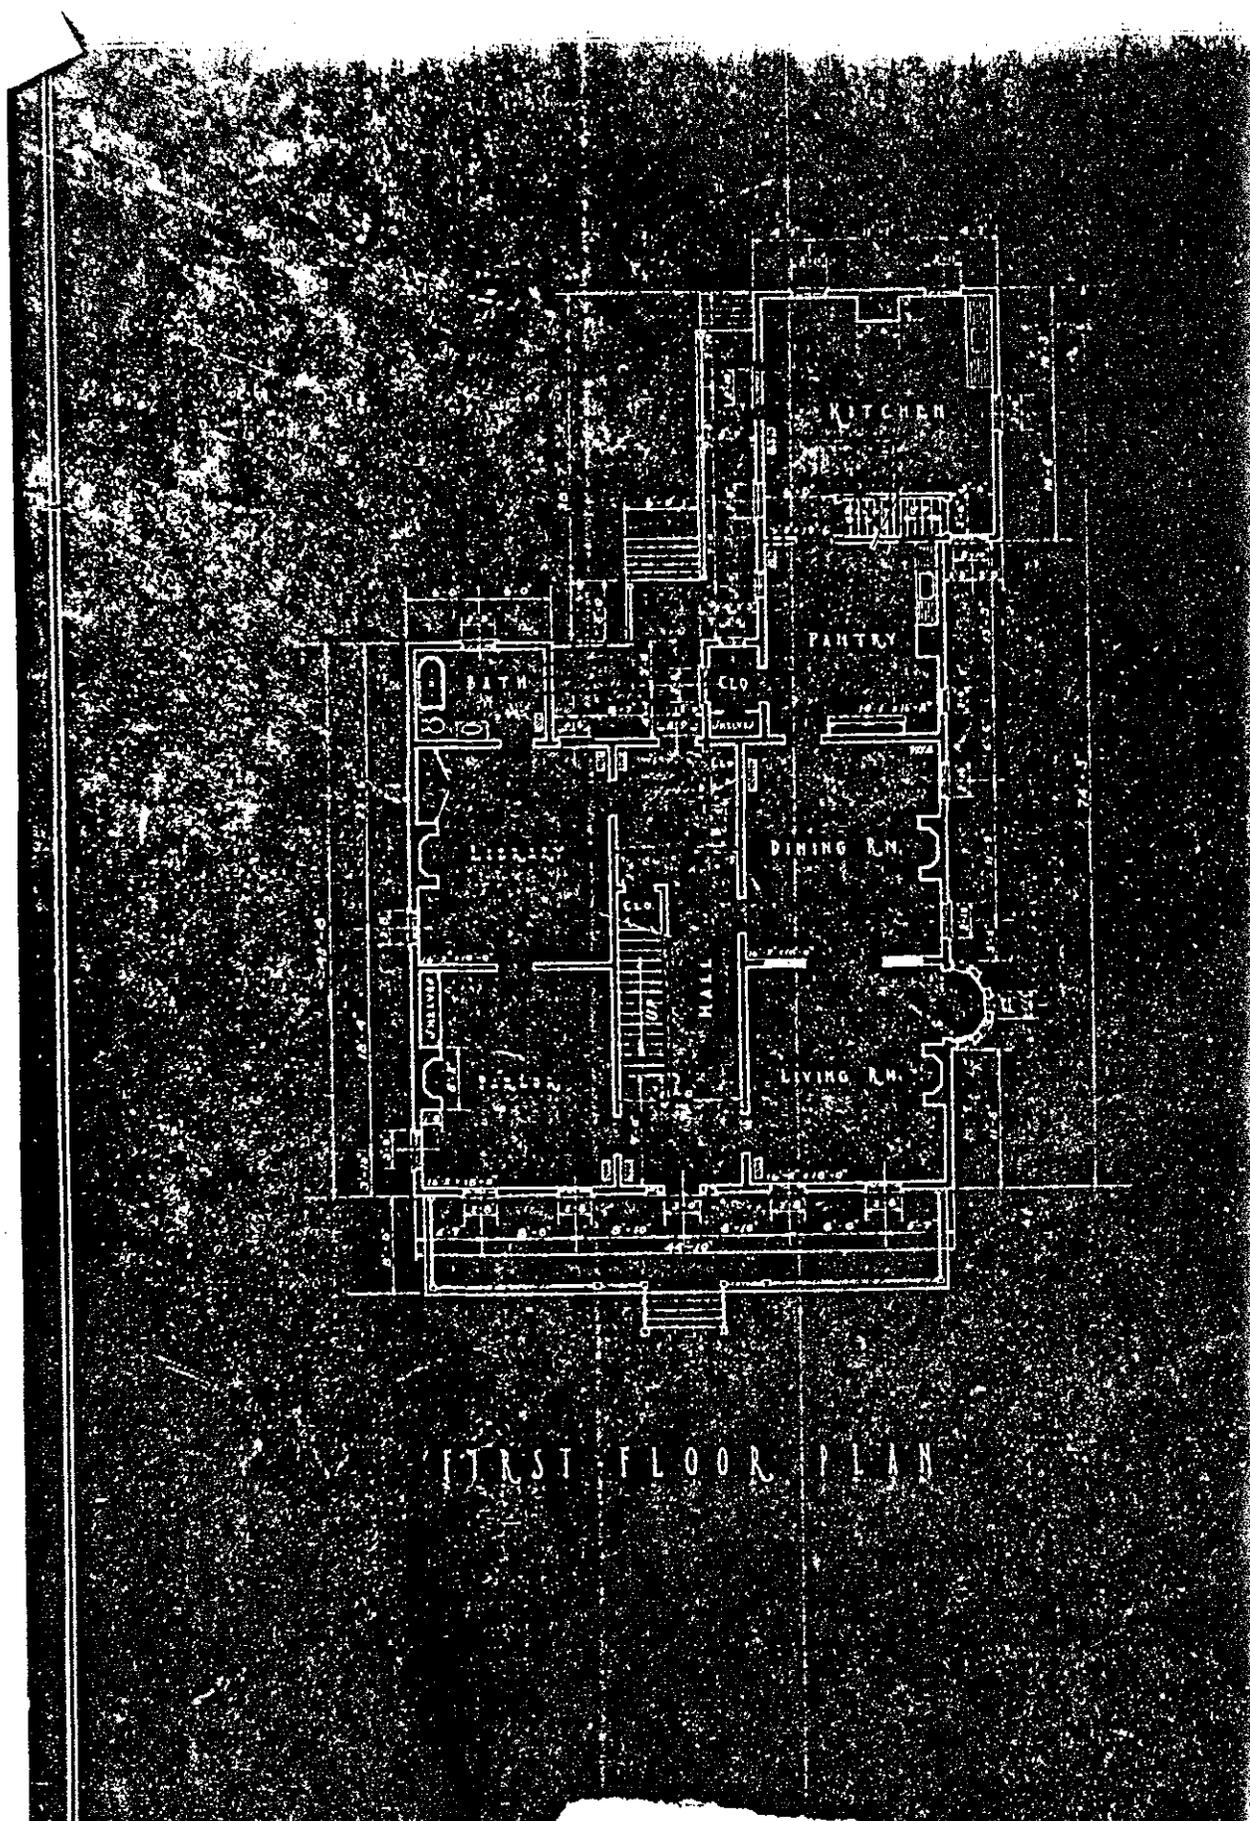
F. Supplemental Material  
1. First floor plan

1. Floor plans: See floor plan attached. Ceilings of the first floor are ten feet and eleven inches in the main block, ten feet in the wing, and nine feet and eight inches in the bath and small rear room (former porch). Second floor ceilings are ten feet with eaves in the main block; the rear hall and bath have seven and a half foot ceilings.

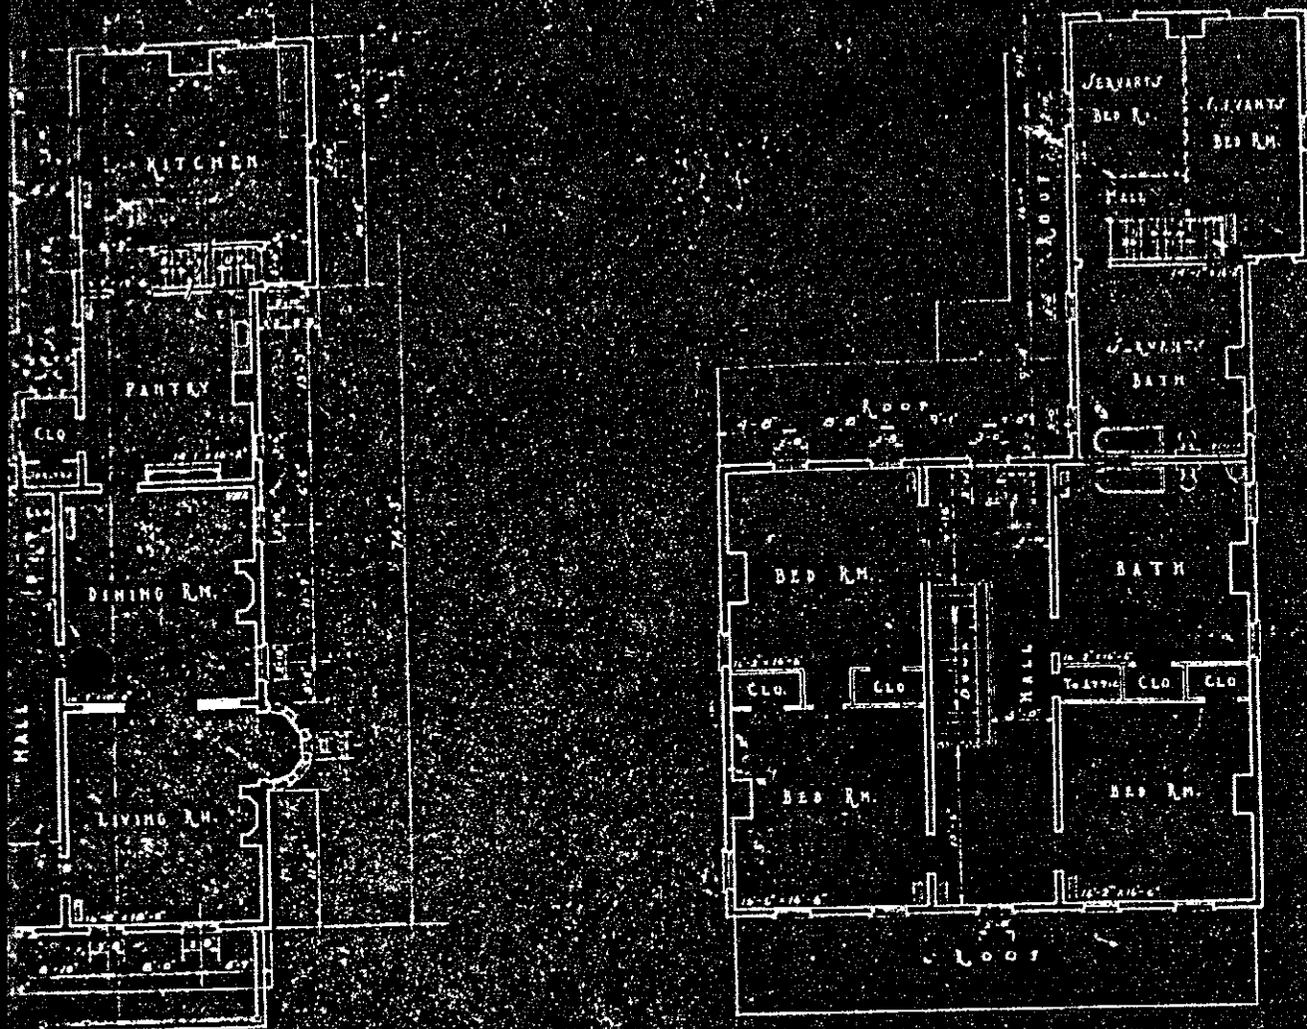
2. Second floor plan

SECOND FLOOR PLAN

OFFICERS QUARTERS  
BUILDING #16

FORT LEAVENWORTH KANS.  
DRAWN IN THE OFFICE OF THE CONST. Q.M.  
FORT LEAVENWORTH KANS.

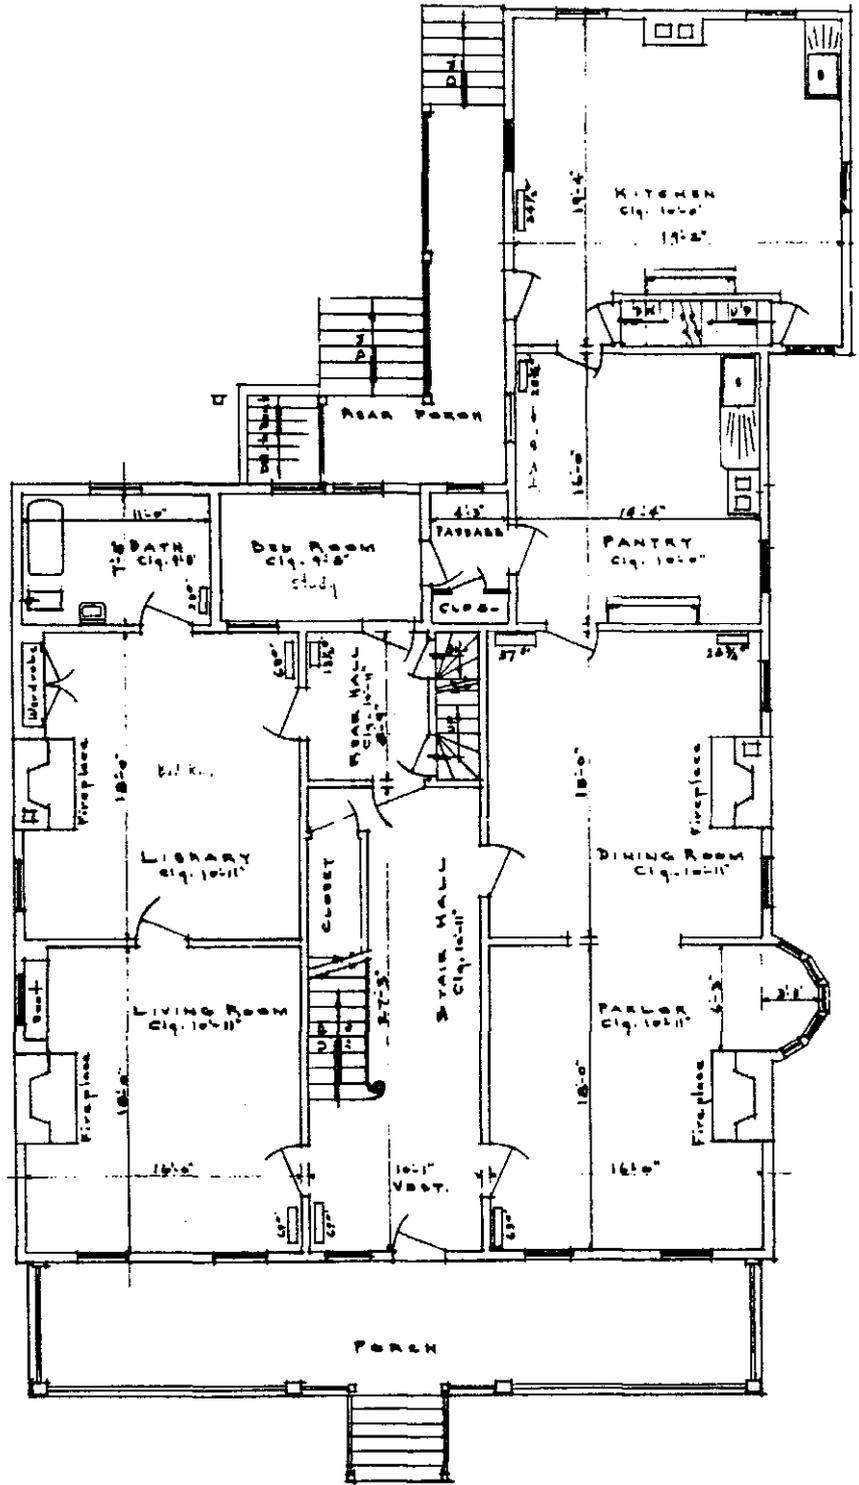
3. First Floor plan

**FIRST FLOOR PLAN**  
SCALE : 1/8" = 1' - 0"

1. Date(s) of erection: 1870 (plan notations: "Col.'s Qtrs.---")
2. Architect: Plans were prepared in the office of Quartermaster General, Washington, D.C.
3. Original and subsequent owners: U.S. Department of War; since 1947 known as the Department of the Army.
4. Builder, contractor, suppliers: Unknown
5. Original plans & construction: Copies of the original floor plans and of the front elevation are at the Fort Leavenworth Museum (see Supplemental Materials # 1 & # 2). Also found, were later, undated floor plans showing the lay-out of the building as it presently exists (see Supplemental Materials

# 3 & # 4).

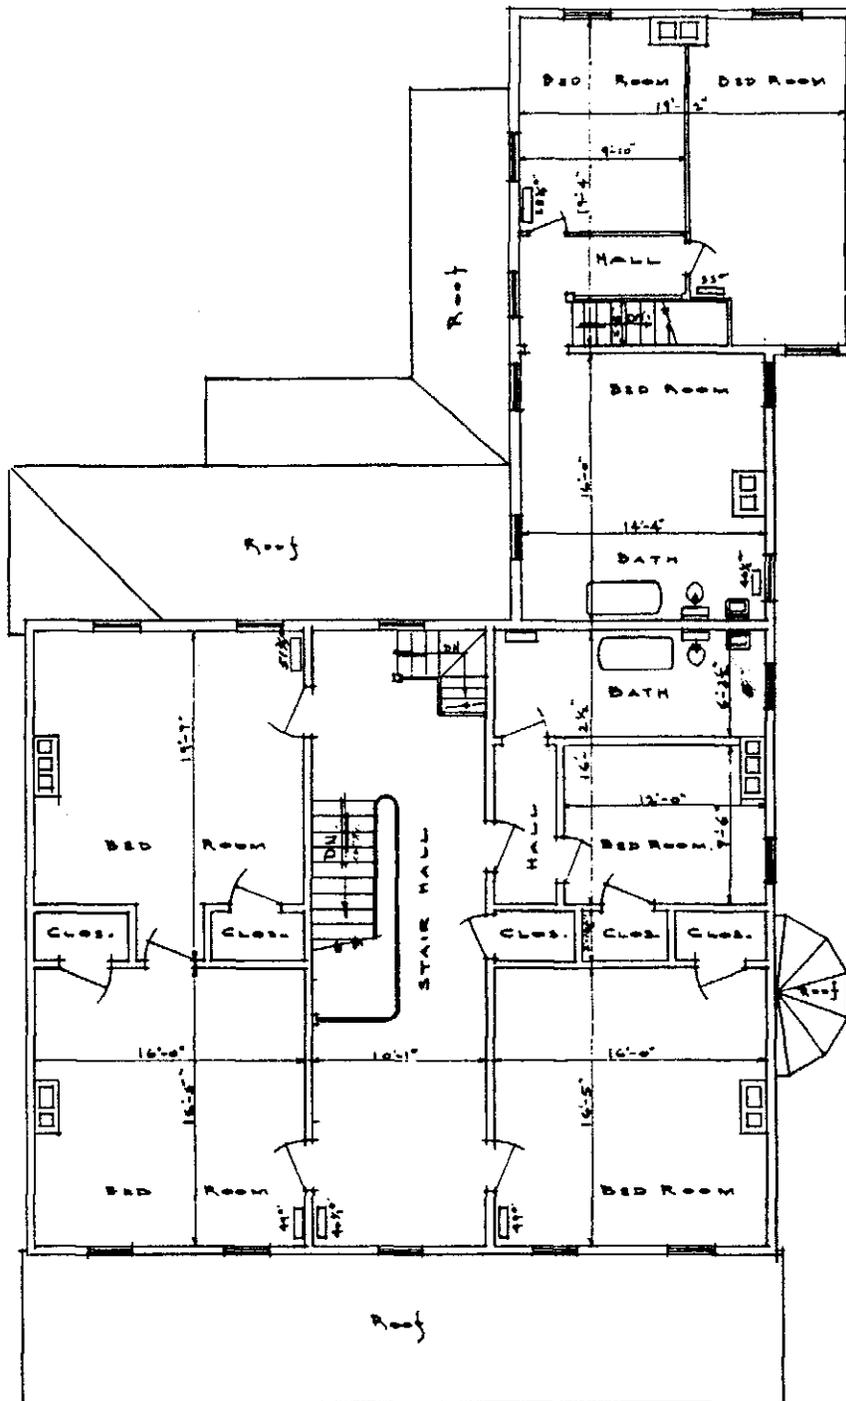
4. Second floor plan

**SECOND FLOOR PLAN**

BLDG. NO. 16 24 SUMNER PLACE

DRAWN BY:	<b>TYPICAL FLOOR PLAN N 10</b>
CHECKED BY:	
SUBMITTED BY:	
APPROVED:	
APPROVED FOR:	
SCALE:	PROJECT NO:
